**18-24 Hill Street,
Lakes Creek**

Proposal Plan
(Proposed Building Location Envelope)
with Ortho Underlay

Landslide Susceptibility Assessment And Geotechnical Comments

SITE ADDRESS: Lot 1 on SP343657
Hill Street, Lakes Creek

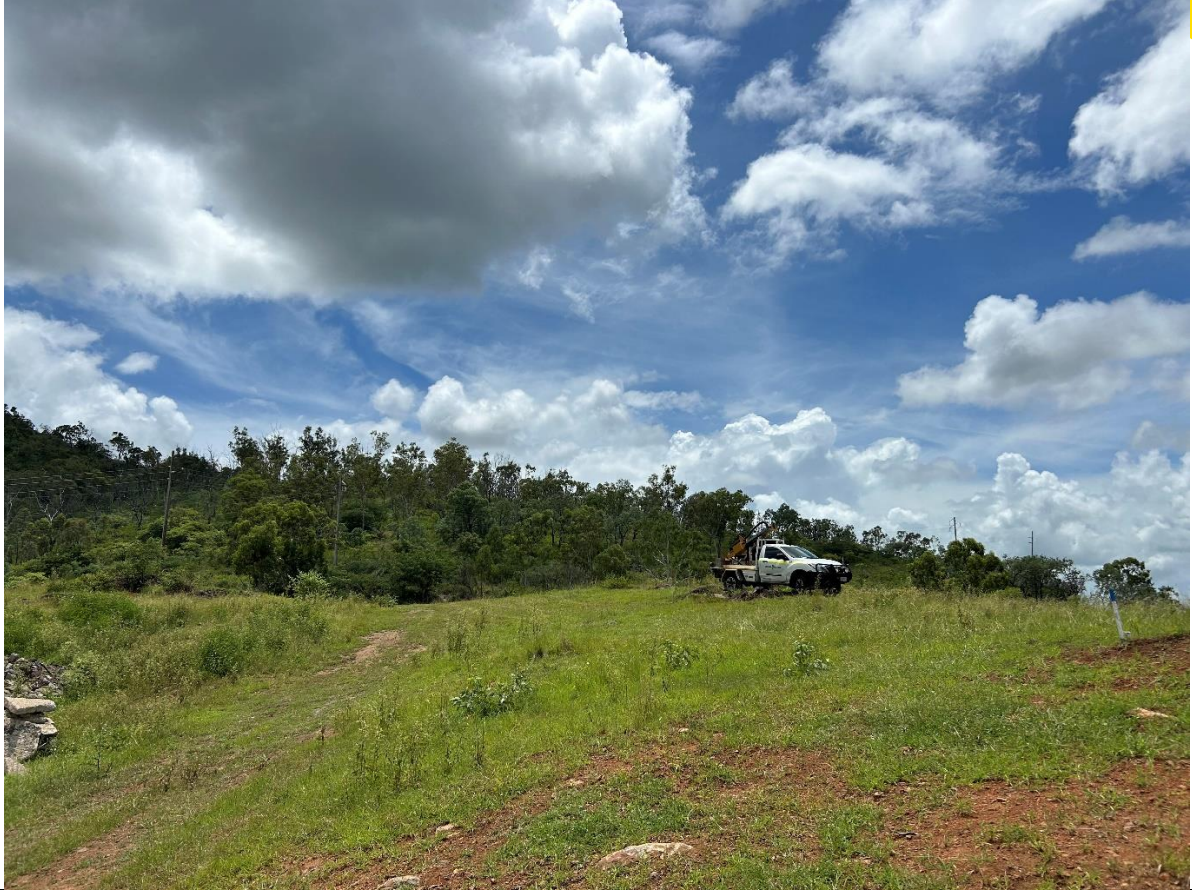
Image 1: Proposed Construction Site

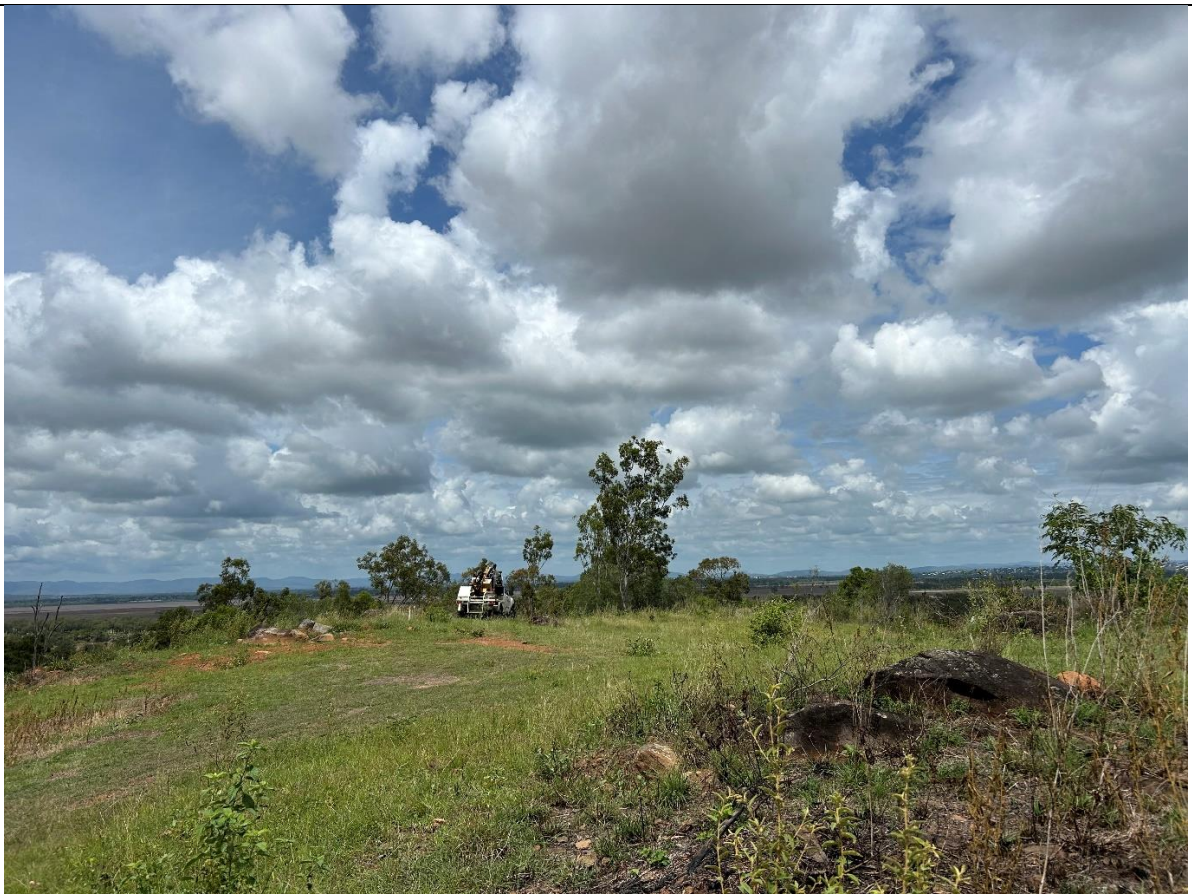
Image 2: Proposed Construction Site

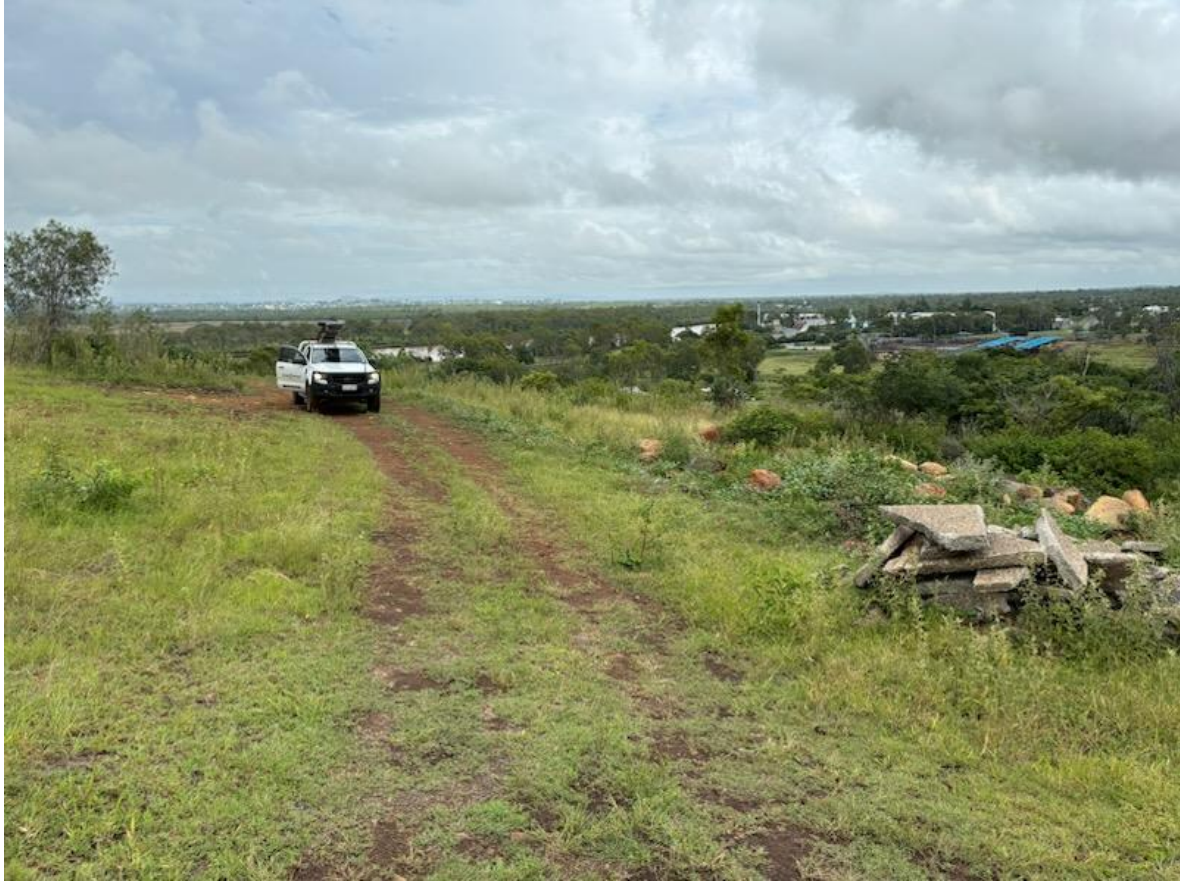
Image 3: Proposed Access Track

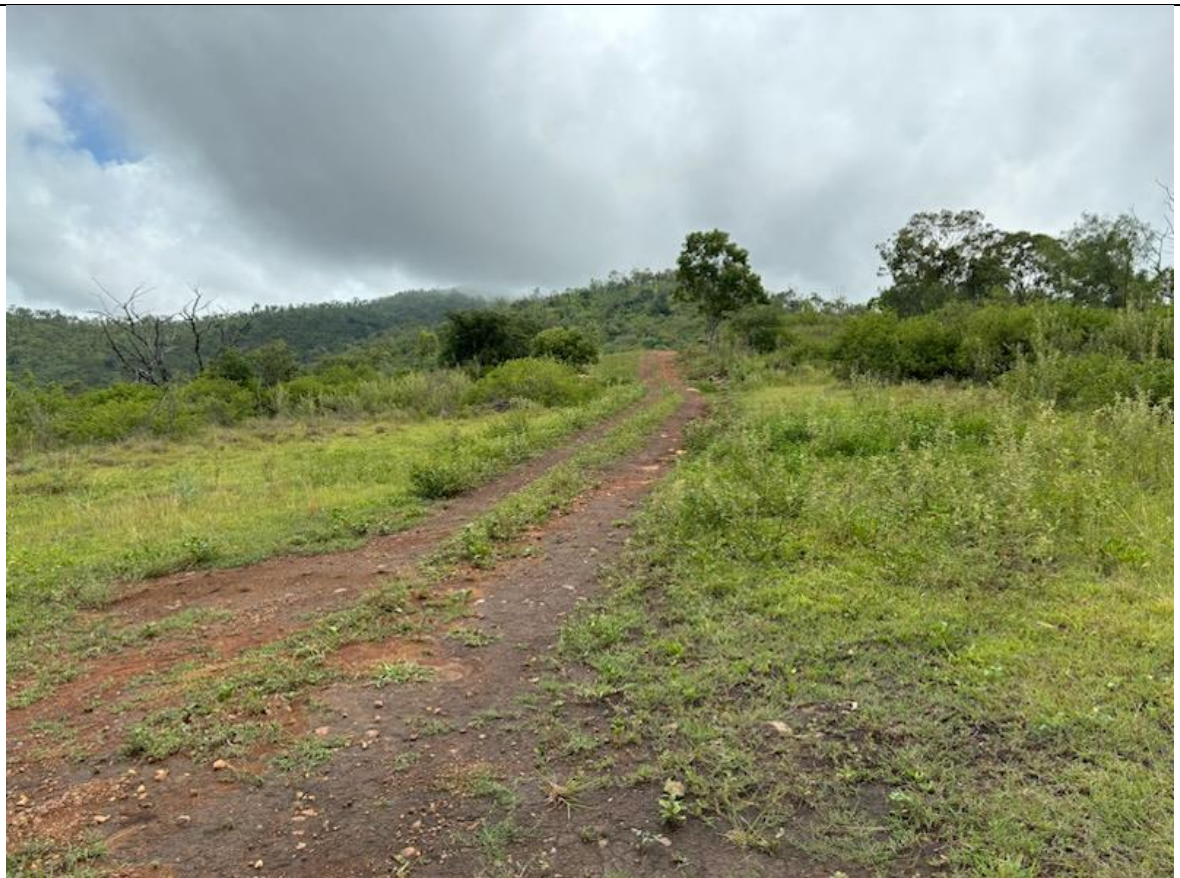
Image 4: Proposed Access Track

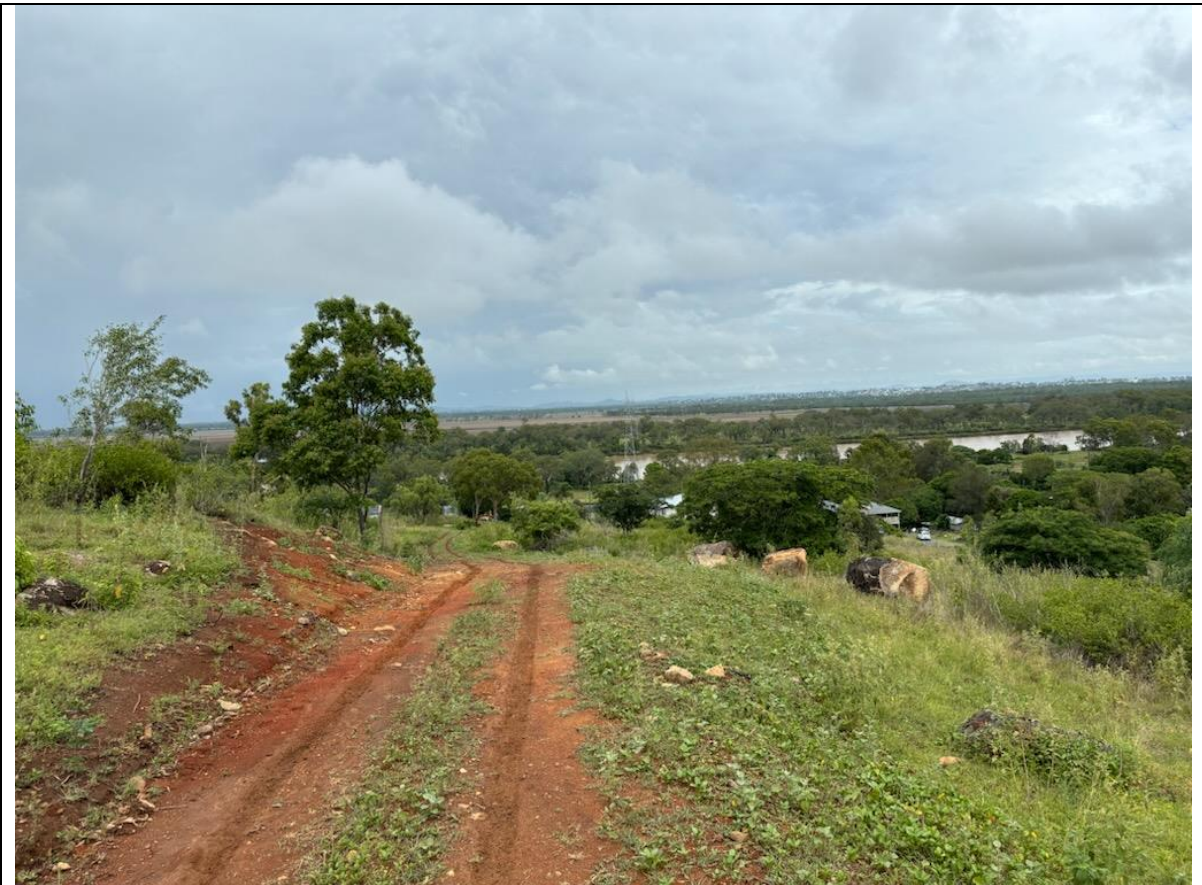
Image 4: Proposed Access Track
