Rockhampton Regional Council

Drinking Water Quality Management Plan

2022-2023

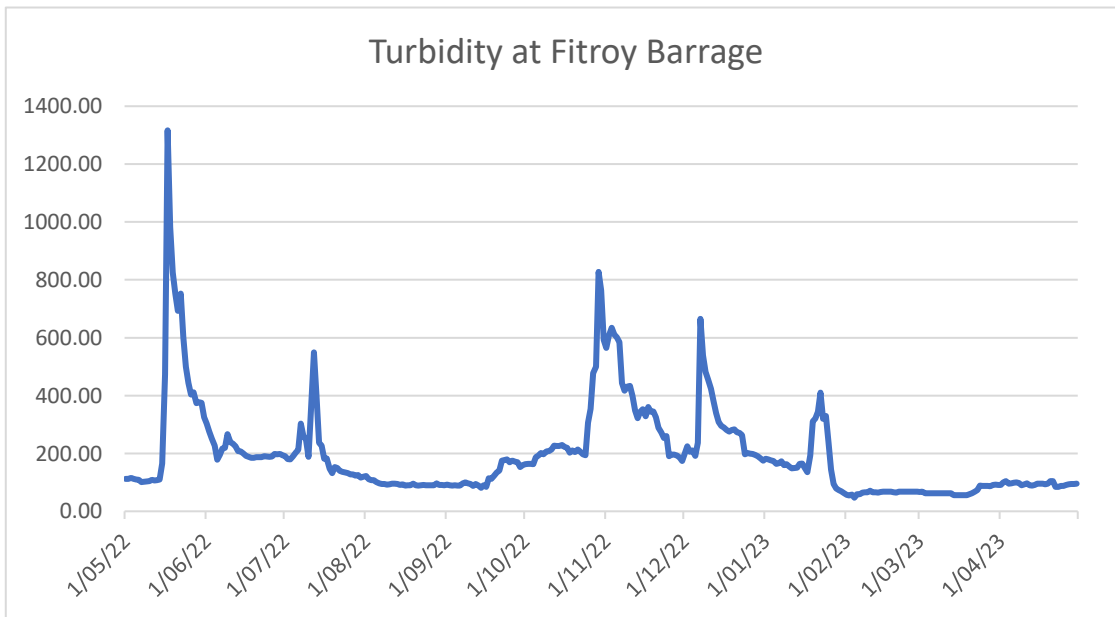
Figure 3.1: Changes in Fitzroy River raw water turbidity based on flow conditions from May 2022 to April 2023 during wet weather events.

Raw water quality in the Fitzroy River typically varies seasonally. This variation is usually flow dependent and is perhaps best illustrated by the changes in turbidity as flow events occur and then gradually decline over subsequent months. Figure 3.1 shows data for raw water turbidity during a wet weather event at the Glenmore WTP between May 2022 and April 2023. During this period, the Fitzroy River changed from having low flow and low turbidity to an extended period of flow events and associated high turbidity from late May 2022 until early 2023 before flows gradually reduced. The high and rapidly changing turbidity seen during this period is typical of these flow events which usually occur at least once a year. The Glenmore WTP effectively treats raw water with high turbidity due to its design and the use of the polyaluminium chlorhydrate coagulant. When raw water turbidity decreases to levels less than 20 NTU or an extended period of time, the river can experience algal blooms which have the potential to affect water quality. The coagulant and polymer dosing rates are adjusted during algal bloom events to treat the water and filter operation is managed closely in order to optimise filter run time and performance during these events.

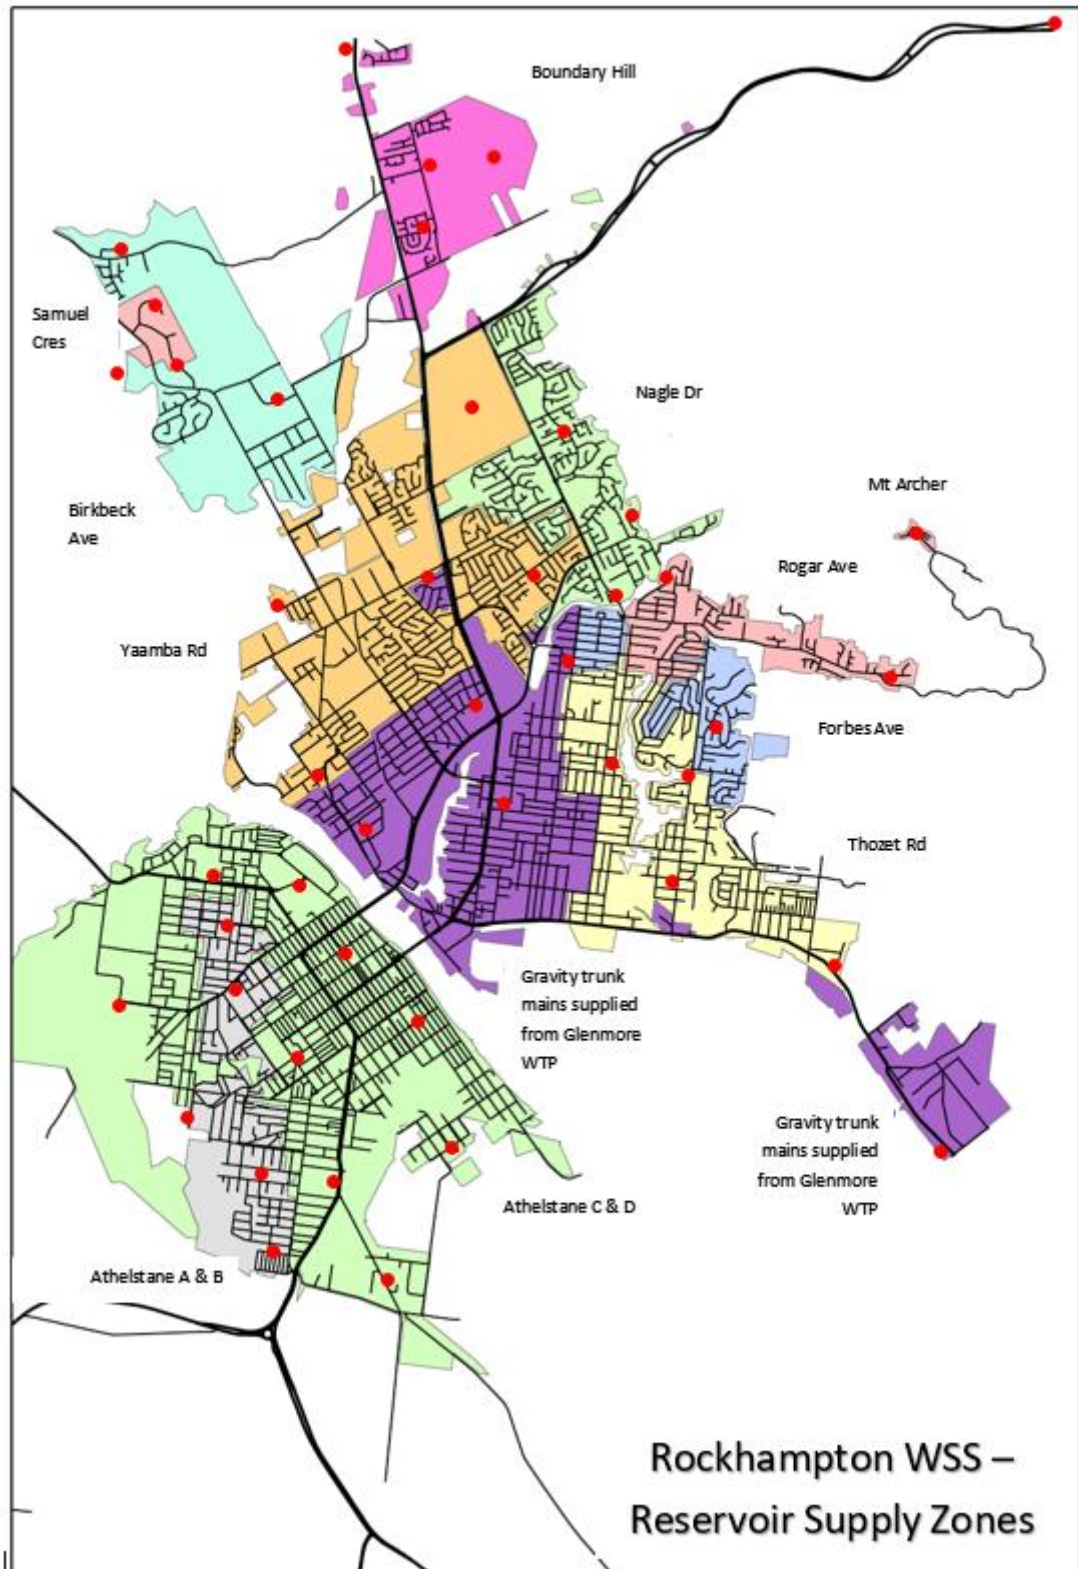
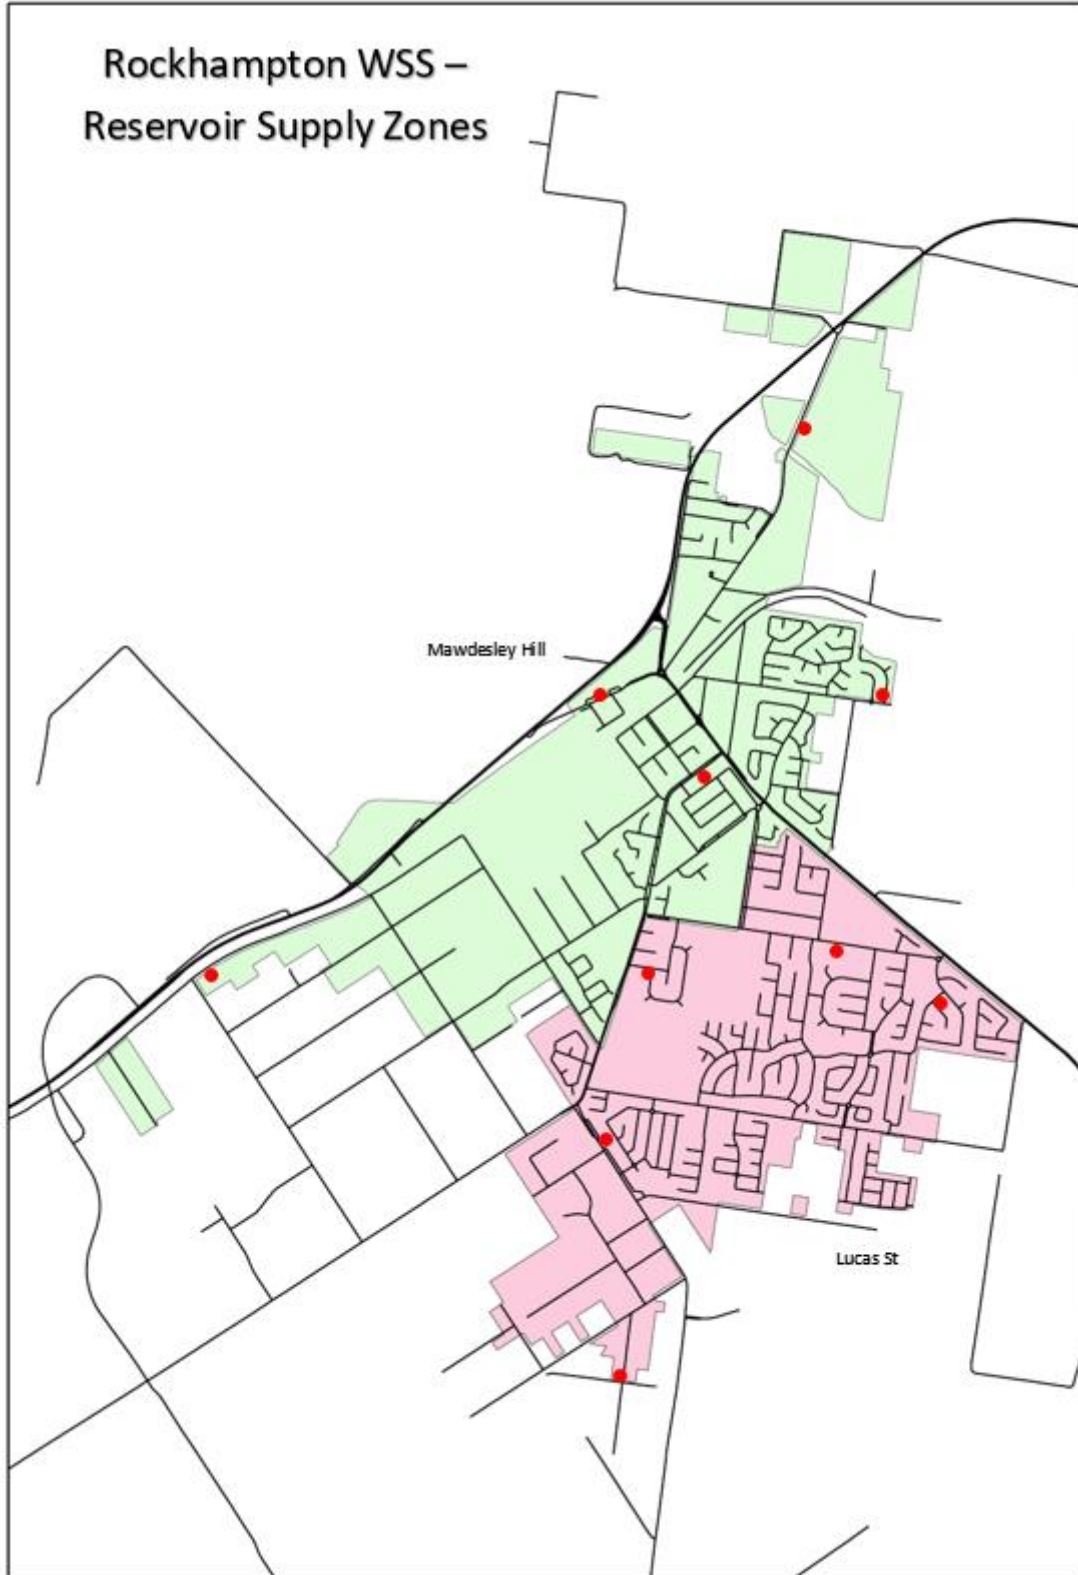
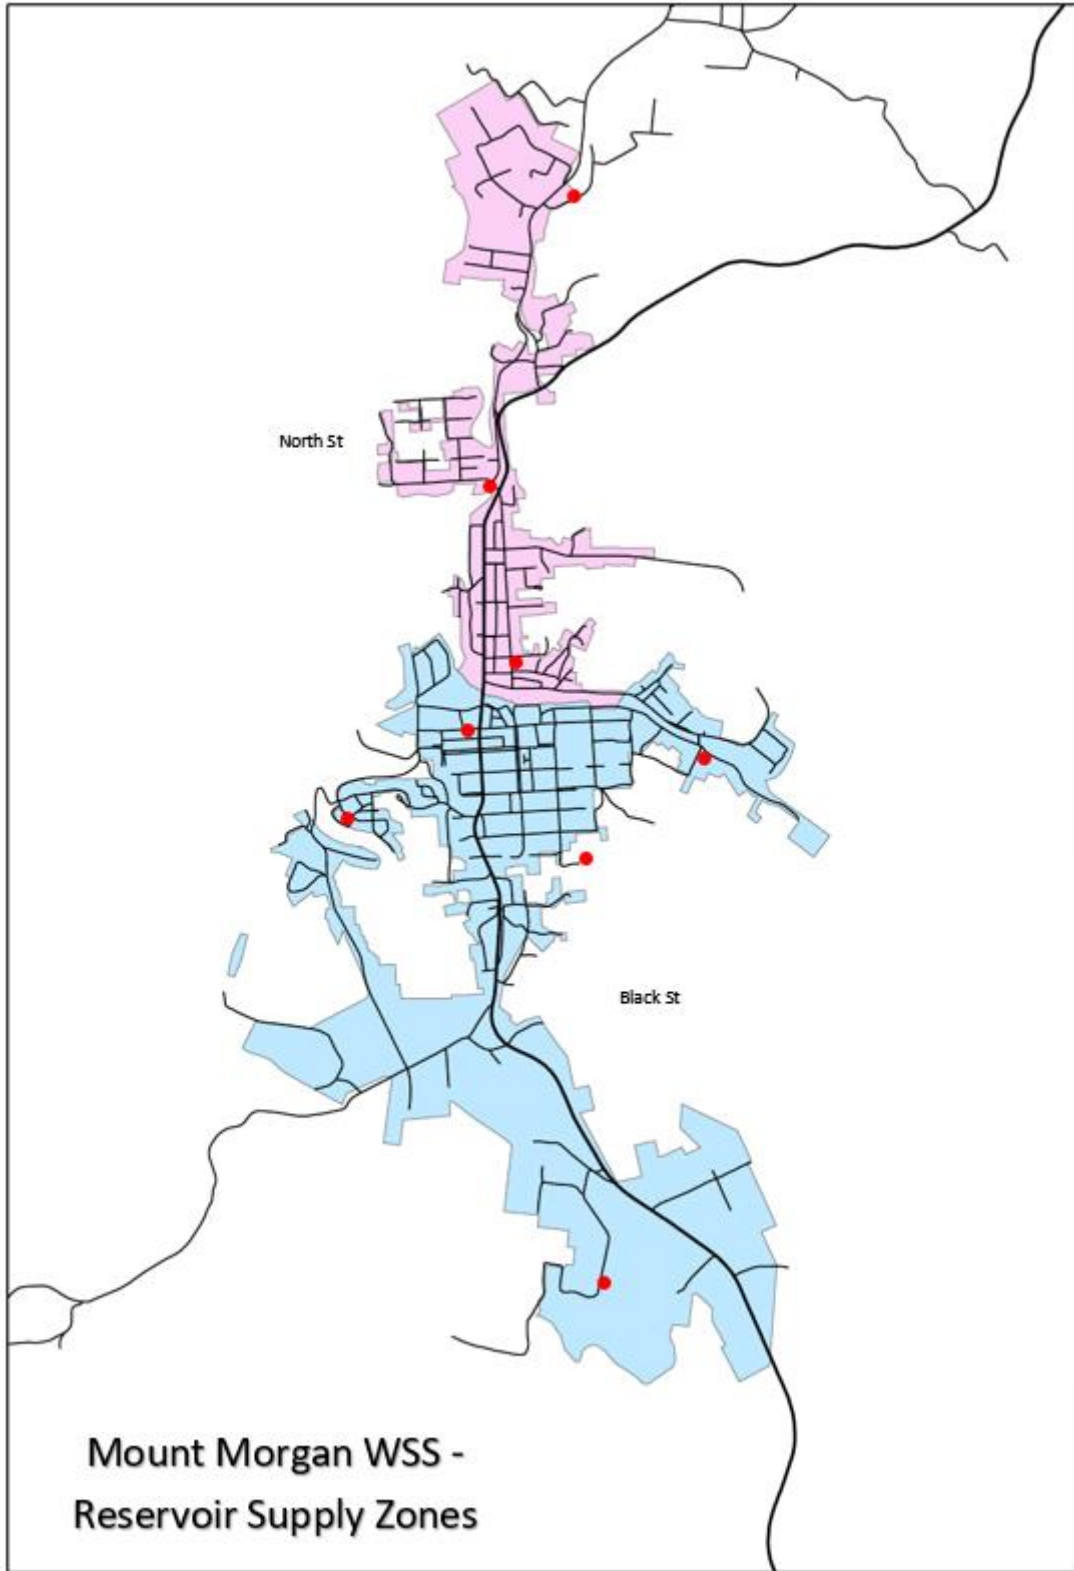
Reservoir water supply zones and sampling points
