Thirsty Creek Quarry

STORMWATER MANAGEMENT PLAN

THIRSTY CREEK QUARRY, GOGANGO

McMurtrie Consulting Engineers (MCE) have been engaged by M H & B J, to prepare a Stormwater Management Plan (SMP) for the proposed Thirsty Creek Quarry located at 802 Thirsty Creek Road, Gogango, described as Lot 21 on PN81 as shown on Figure 1.

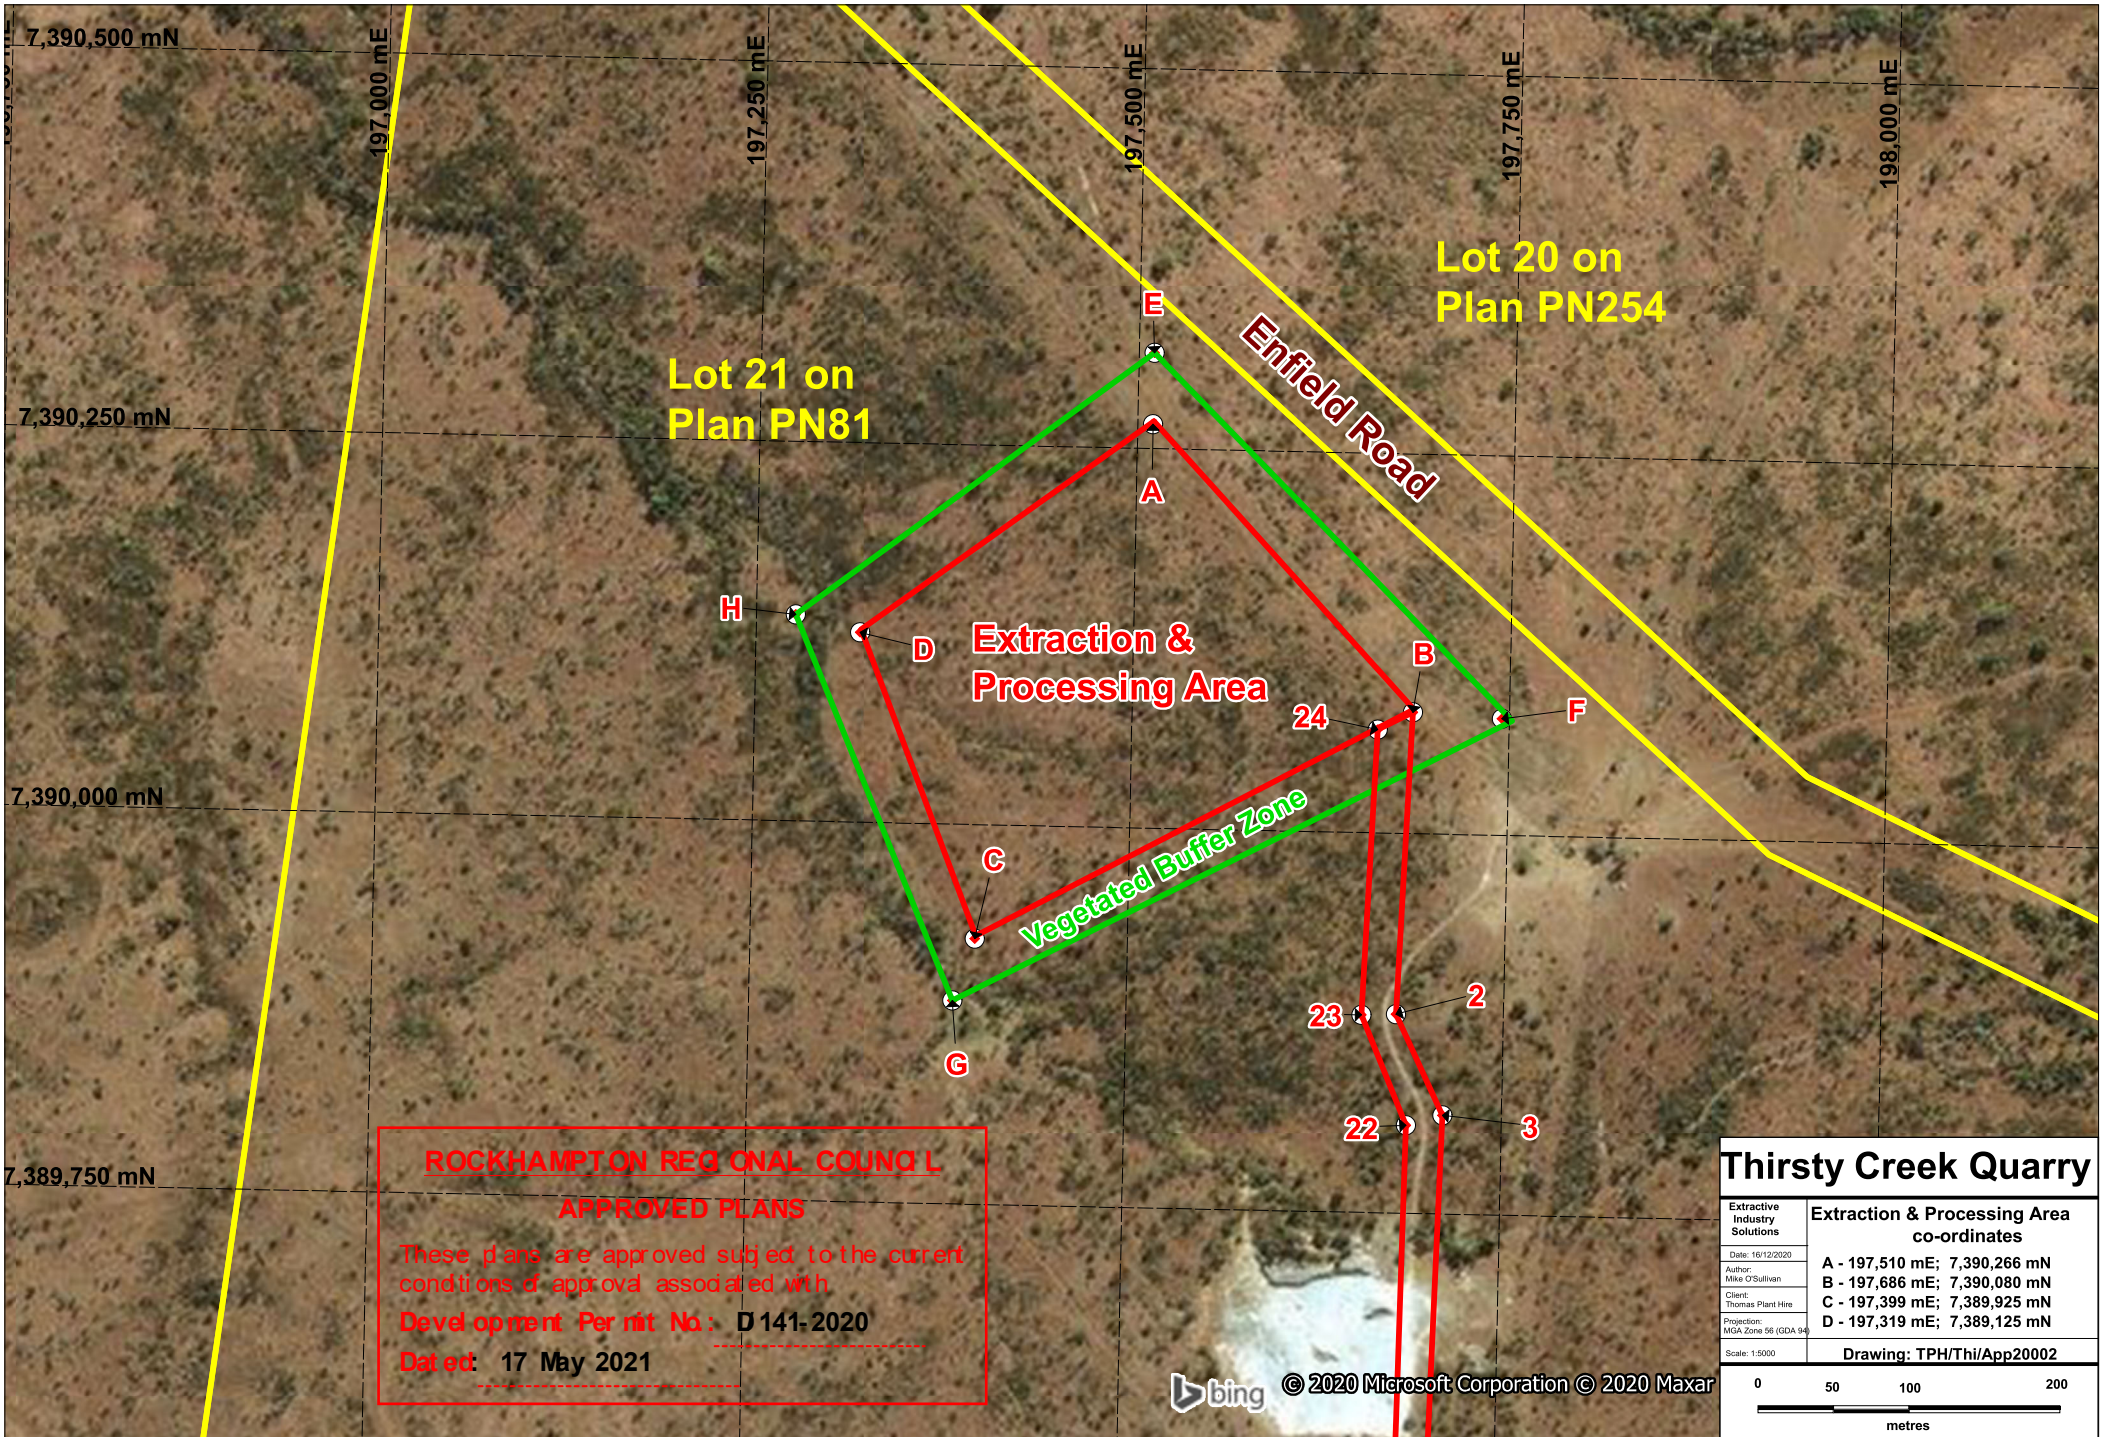
Drawing: TPH/Thi/App20002

Extraction & Processing Area

Vegetated Buffer Zone

Extraction & Processing Area co-ordinates

- A - 197,510 mE; 7,390,266 mN
- B - 197,686 mE; 7,390,080 mN
- C - 197,399 mE; 7,389,925 mN
- D - 197,319 mE; 7,389,125 mN

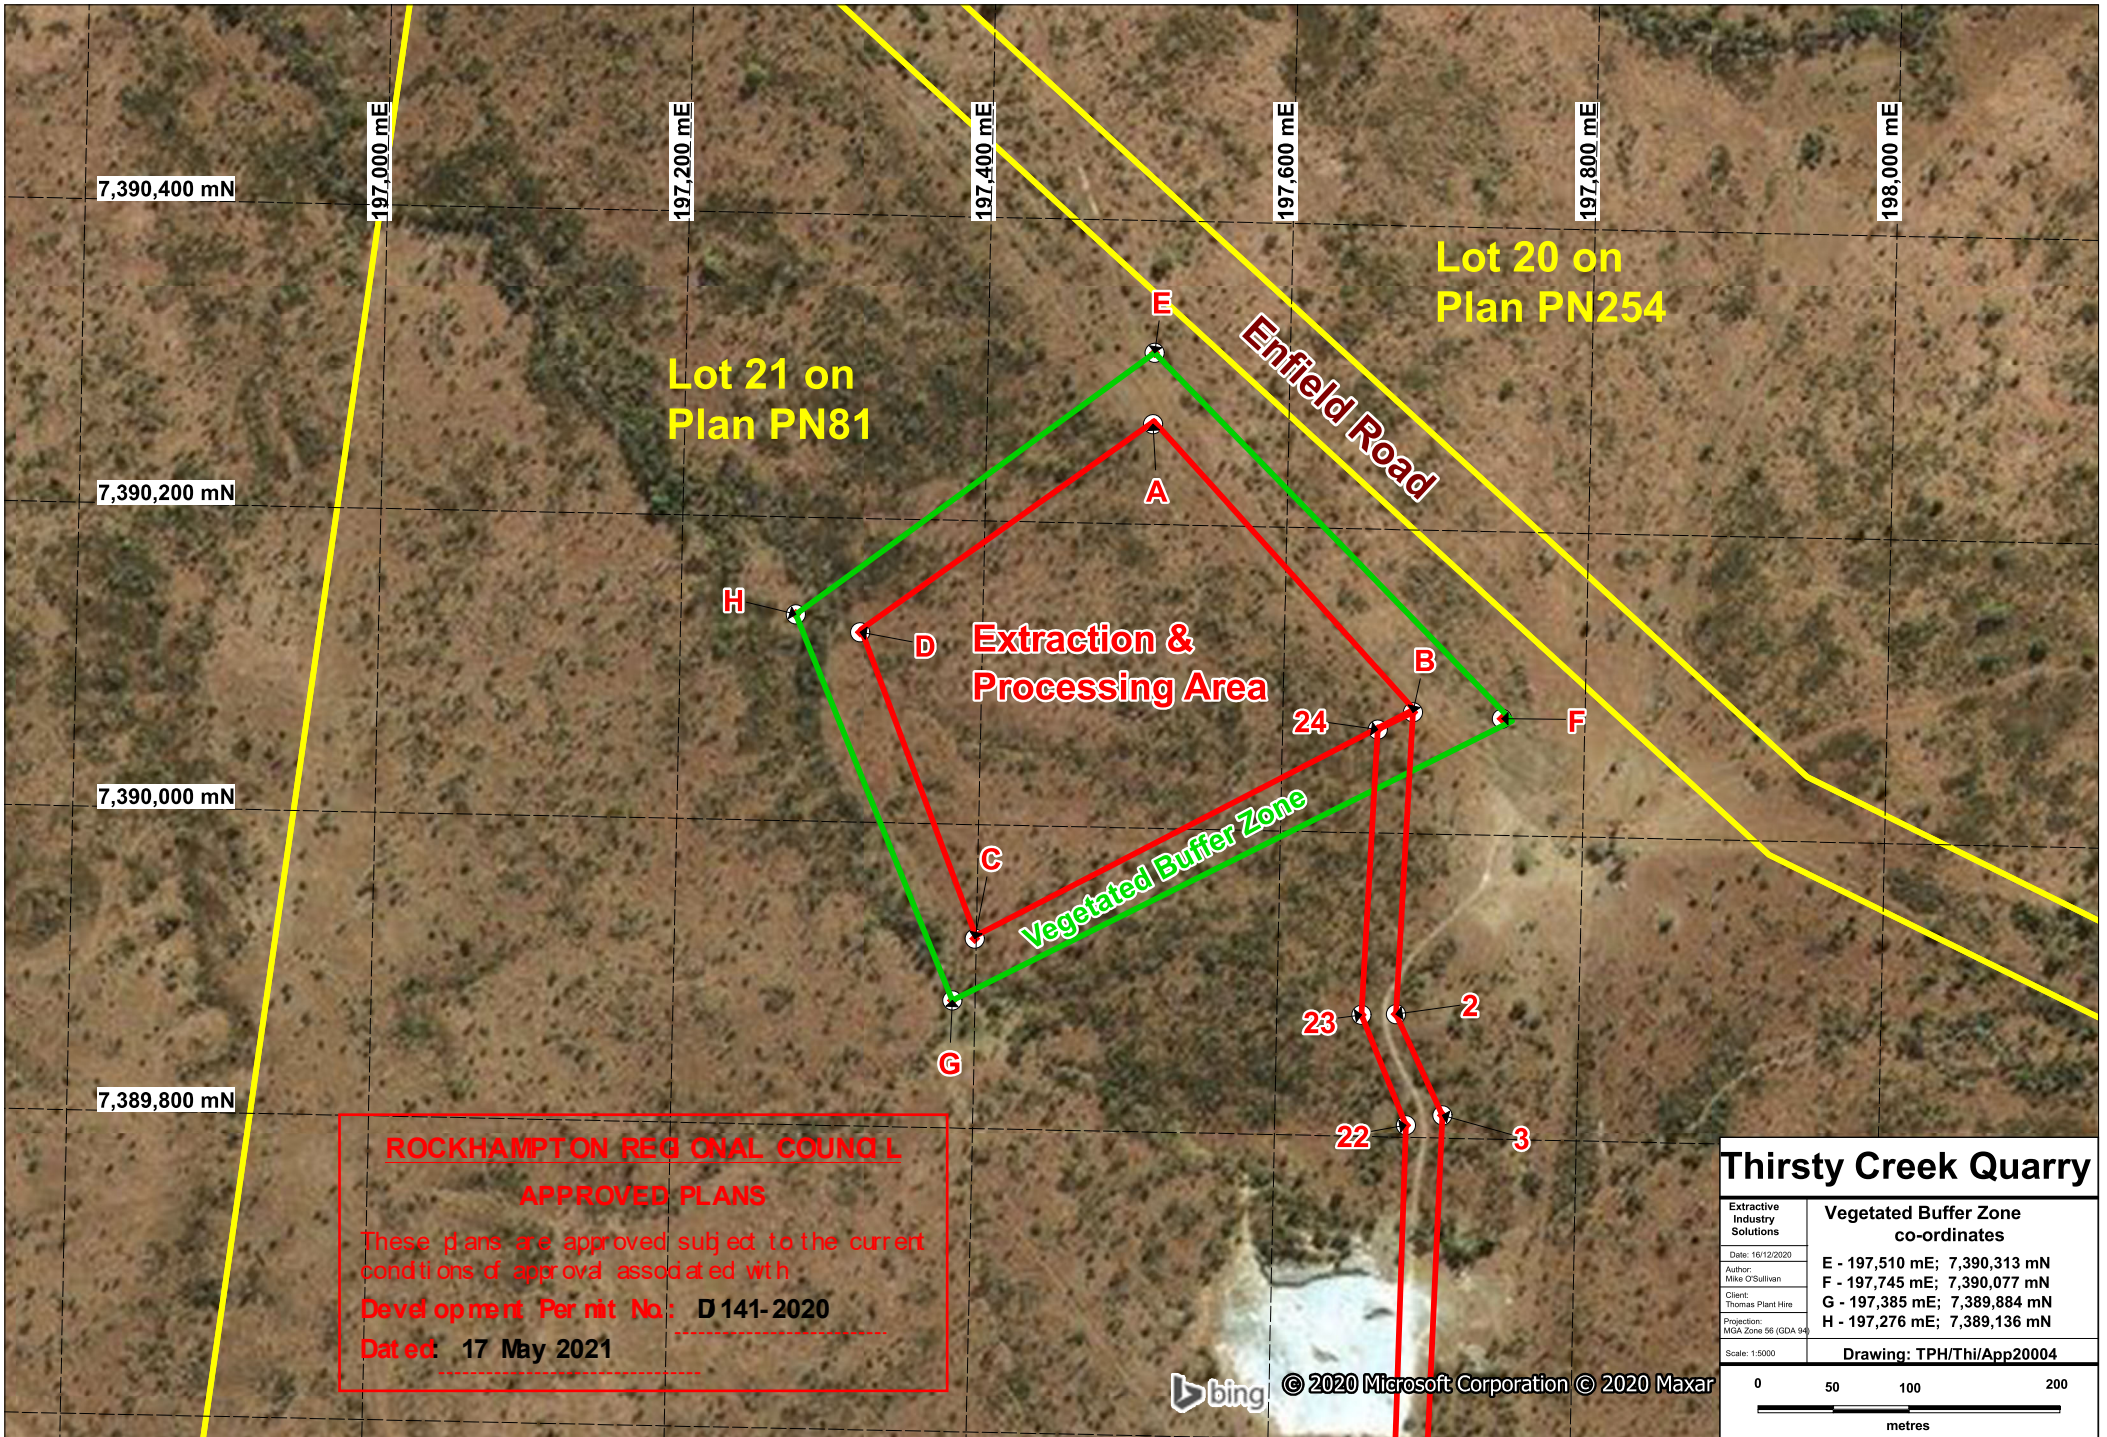
Extraction &
Processing Area

Vegetated Buffer Zone

Extractive Industry Solutions	Vegetated Buffer Zone co-ordinates
Date: 16/12/2020	E - 197,510 mE; 7,390,313 mN
Author: Mike O'Sullivan	F - 197,745 mE; 7,390,077 mN
Client: Thomas Plant Hire	G - 197,385 mE; 7,389,884 mN
Projection: MGA Zone 56 (GDA 94)	H - 197,276 mE; 7,389,136 mN
Scale: 1:5000	Drawing: TPH/Thi/App20004

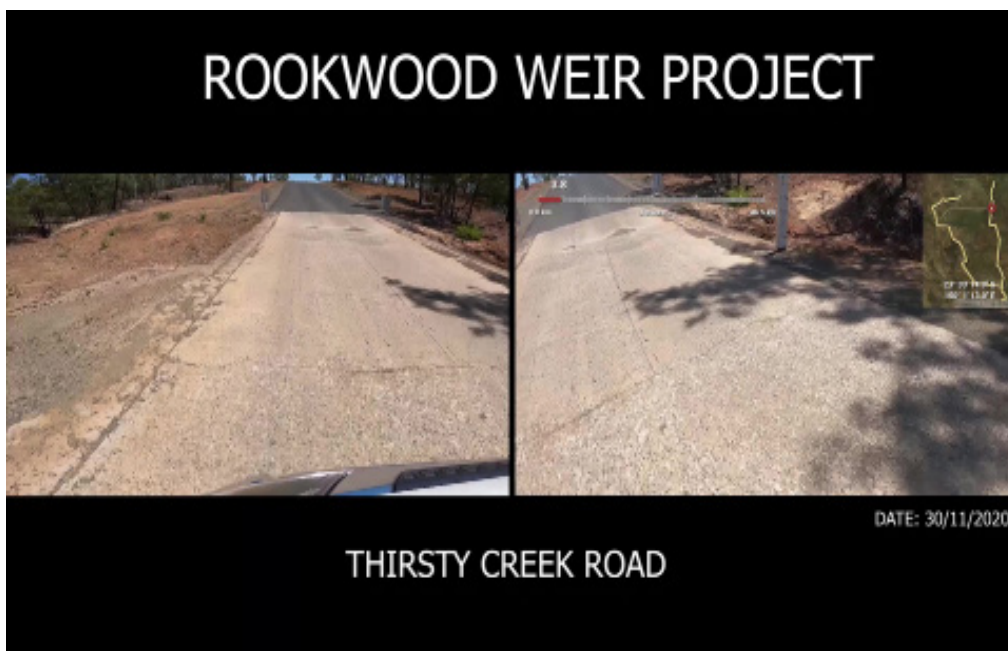
Figure: 0033

33	Culvert	Thirsty Creek Rd	Pavement	Concrete	BZ	Cracks	23° 33' 14.0" S	150° 1' 13.0" E	Video	Left side - Right Side	00033			
34	Culvert	Thirsty Creek Rd	Pavement	Concrete	BZ	Cracks	23° 33' 14.2" S	150° 1' 12.9" E	Video	Left side - Right Side	00034			
35	Culvert	Thirsty Creek Rd	Pavement	Concrete	BZ	Cracks	23° 33' 14.9" S	150° 1' 12.9" E	Video	Left side - Right Side	00035			
36	Roadway	Thirsty Creek Rd	Shoulder	Unsealed/ Gravel	CC	Edge Drop-off/ Roolover	23° 33' 29.1" S	150° 1' 9.2" E	Video	Left Side	00036			
37	Culvert	Thirsty Creek Rd	Pavement	Concrete	BZ	Cracks	23° 33' 50.6" S	150° 1' 6.2" E	Video	Left side - Right Side	00037

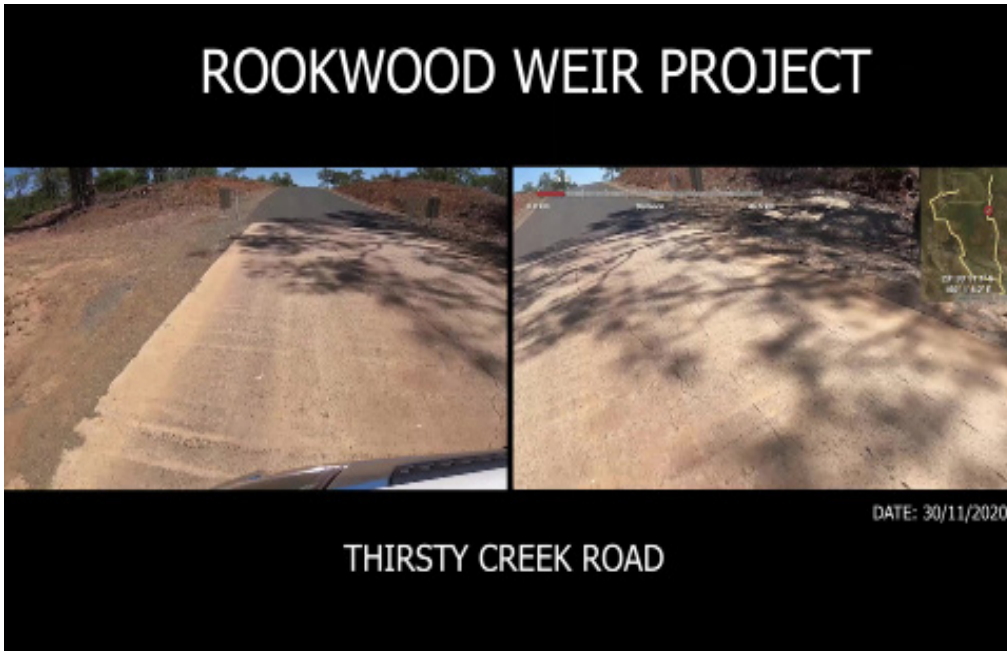
Figure: 0040

Inspection Codes	AA = Depressions, AB = Ruts in Bituminous Surface, AD = Shoving of Pavement, AF = Rough Surface, AG = Potholes/ Delamination, BG = Crocodile Cracking, BZ = Cracks, CA = Edge Break, CC = Edge Drop-off/ Roolover, DC = Bleeding Seal, DE = Ravelling/ Stripping Seal, EB = Grass, GC = Scour/ Sediment Built-up, GG = Debries, HD = Wheel Ruts, YB = Joints Spalling/ Defects, TB = General Defect													
	Ref.#	Asset	Road Name	Element	Element Type	Defect Code	Defect Description	Coordination		Type of Inspection	Comment	Photo(s)		
								Lan	Lot			1	2	3
38	Culvert	Thirsty Creek Rd	Pavement	Concrete	BZ	Cracks	23° 33' 50.8" S	150° 1' 6.2" E	Video	Left side - Right Side	00038			
39	Culvert	Thirsty Creek Rd	Pavement	Concrete	BZ	Cracks	23° 33' 50.9" S	150° 1' 6.2" E	Video	Left side - Right Side	00039			
40	Culvert	Thirsty Creek Rd	Pavement	Concrete	BZ	Cracks	23° 33' 51.1" S	150° 1' 6.2" E	Video	Left side - Right Side	00040

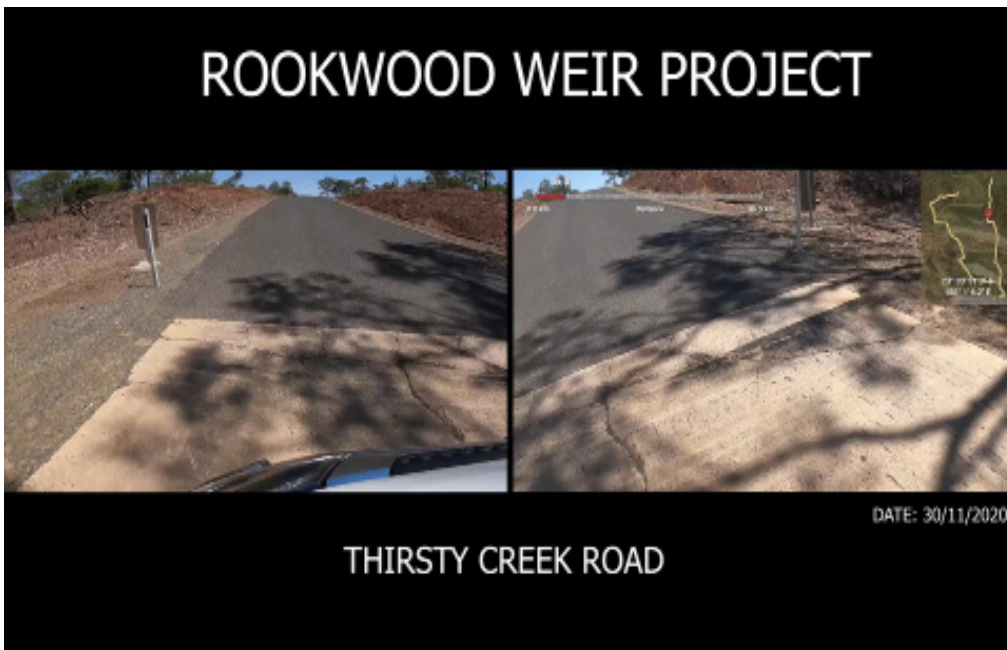
Figure: 0041

41	Culvert	Thirsty Creek Rd	Pavement	Concrete	BZ	Cracks	23° 33' 51.3" S	150° 1' 6.2" E	Video	Left side - Right Side	00041			
42	Roadway	Thirsty Creek Rd	Shoulder	Unsealed/ Gravel	GC	Scour/ Sediment Built-up	23° 34' 8.3" S	150° 1' 3.2" E	Video	Left side - Right Side	00042			
43	Roadway	Thirsty Creek Rd	Pavement	Concrete	BZ	Cracks	23° 34' 8.5" S	150° 1' 3.2" E	Video	Right Side	00043			
44	Roadway	Thirsty Creek Rd	Pavement	Asphalt/ Bitumen	DC	Bleeding Seal	23° 34' 12.6" S	150° 1' 2.7" E	Video	Left Side	00044			
45	Roadway	Thirsty Creek Rd	Pavement	Asphalt/ Bitumen	GC	Scour/ Sediment Built-up	23° 34' 12.7" S	150° 1' 2.7" E	Video	-	00045			
46	Roadway	Thirsty Creek Rd	Pavement	Asphalt/ Bitumen	DE	Ravelling/ Stripping Seal	23° 34' 13.4" S	150° 1' 2.6" E	Video	Left Side	00046			
47	Roadway	Thirsty Creek Rd	Pavement	Asphalt/ Bitumen	GC	Scour/ Sediment Built-up	23° 34' 14.8" S	150° 1' 2.3" E	Video	Left side - Right Side	00047

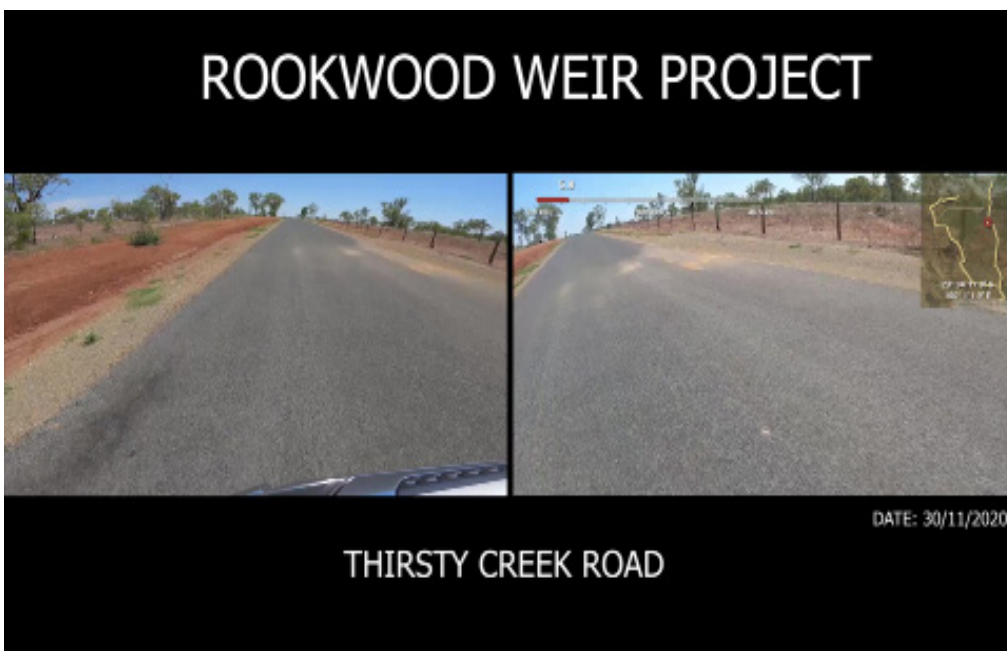
Figure: 0048

48	Roadway	Thirsty Creek Rd	Pavement	Asphalt/ Bitumen	GC	Scour/ Sediment Built-up	23° 34' 17.8" S	150° 1' 1.9" E	Video	Right Side	00048			
49	Roadway	Thirsty Creek Rd	Pavement	Asphalt/ Bitumen	BZ	Cracks	23° 34' 21.7" S	150° 1' 1.3" E	Video	Middle	00049			
50	Roadway	Thirsty Creek Rd	Pavement	Asphalt/ Bitumen	DC	Bleeding Seal	23° 34' 26.6" S	150° 1' 0.9" E	Video	Left Side	00050			
51	Roadway	Thirsty Creek Rd	Pavement	Asphalt/ Bitumen	DC	Bleeding Seal	23° 34' 29.3" S	150° 1' 3.4" E	Video	Right Side	00051			
52	Roadway	Thirsty Creek Rd	Pavement	Asphalt/ Bitumen	GC	Scour/ Sediment Built-up	23° 34' 29.8" S	150° 1' 7.6" E	Video	Left side - Right Side	00052			
53	Roadway	Thirsty Creek Rd	Pavement	Asphalt/ Bitumen	DC	Bleeding Seal	23° 34' 30.1" S	150° 1' 10.3" E	Video	Left Side	00053			
54	Roadway	Thirsty Creek Rd	Pavement	Asphalt/ Bitumen	GC	Scour/ Sediment Built-up	23° 34' 30.6" S	150° 1' 14.3" E	Video	Left side - Right Side	00054
