# **Edenbrook Estate Edenbrook Drive, Parkhurst**

# Concept Plan

Report on Geotechnical Stability Assessment

Proposed Subdivision Edenbrook Estate (Precinct 2) Edenbrook Drive, Parkhurst

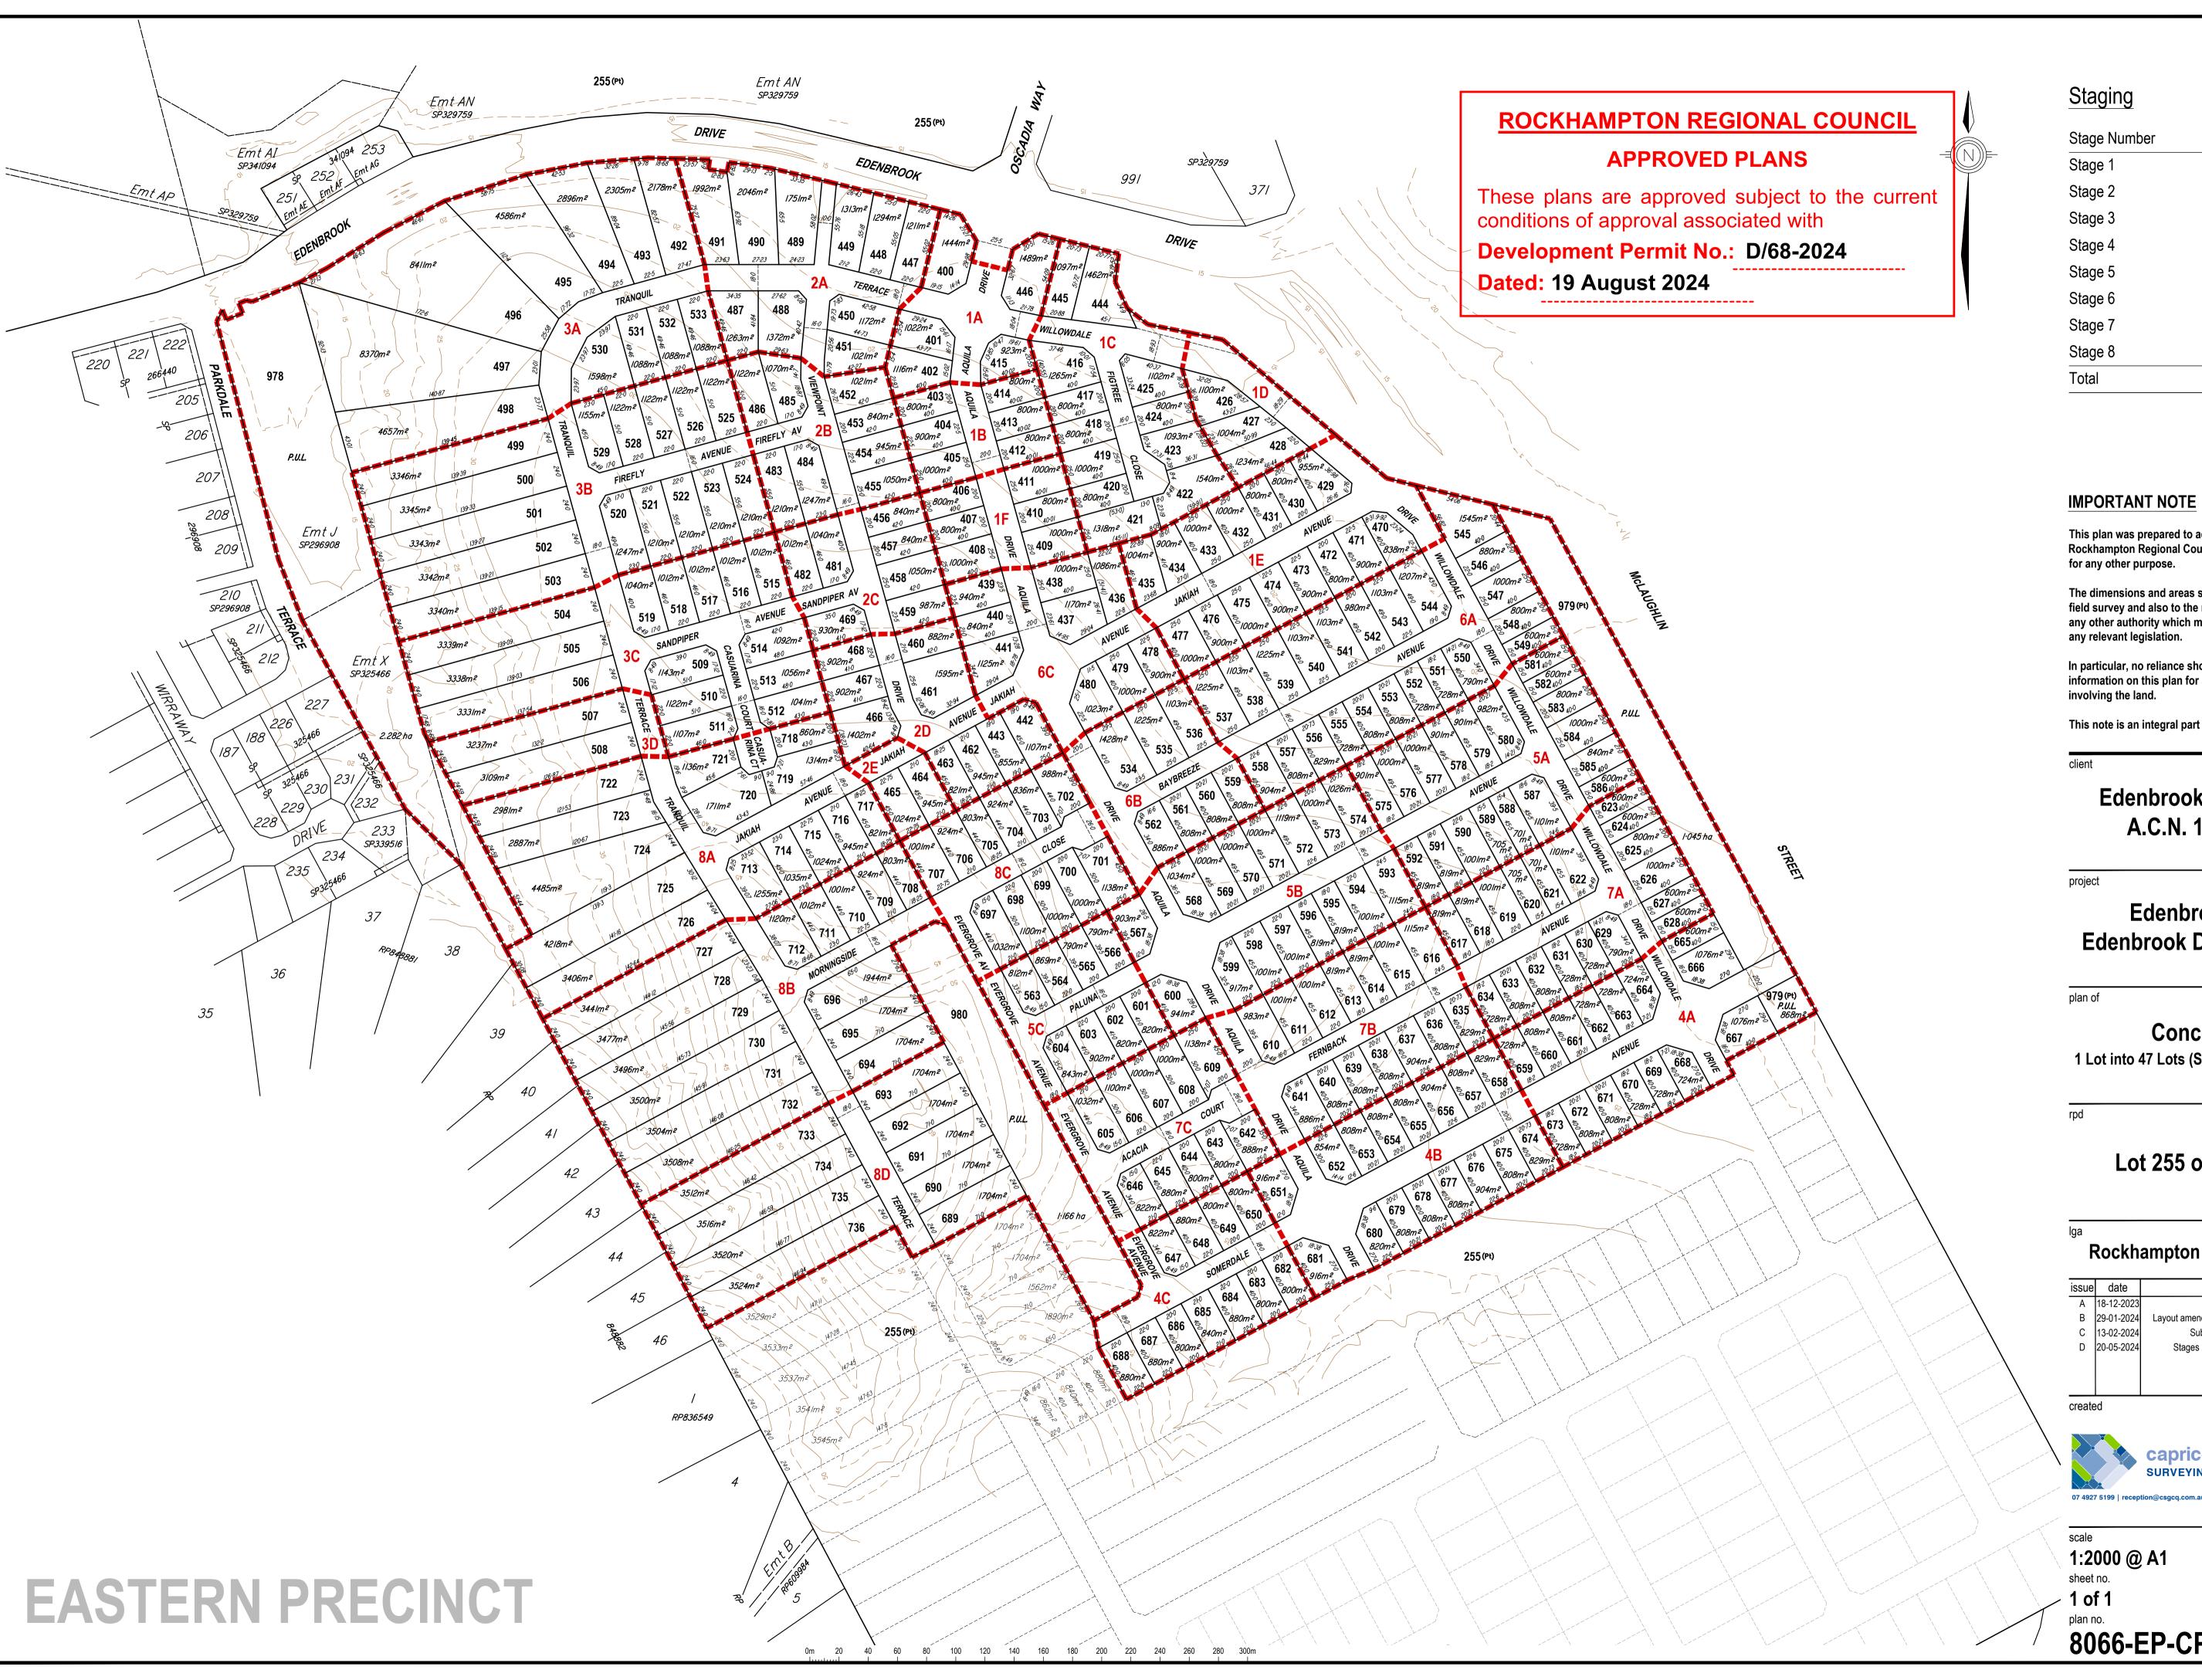
8066-EP-CPT

ı
Stage Number	Lots
Stage 1	47
Stage 2	36
Stage 3	42
Stage 4	42
Stage 5	42
Stage 6	38
Stage 7	42
Stage 8	48
Total	337

1 Lot into 47 Lots (Stage 1) + 290 Lots + Bal)

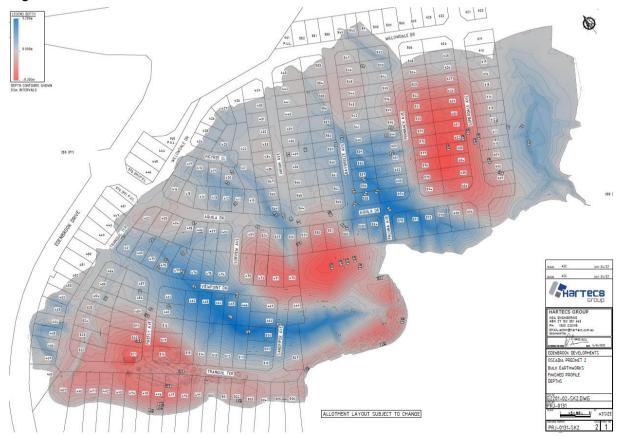
Figure 2: Proposed earthworks for a proportion of the overall site.

It is further understood that the proposed earthworks for a portion of the overall site will consist of bulk excavations up to approximately 7 m in height along the ridgeline and spurs, and filling up to approximately 9 m in the low lying re-entrants between the spurs (refer to Figure 2); generally creating relatively flat and level building platforms, some locally increasing up to approximately 15%. It is anticipated that similar earthworks will be required for the remainder of the site.

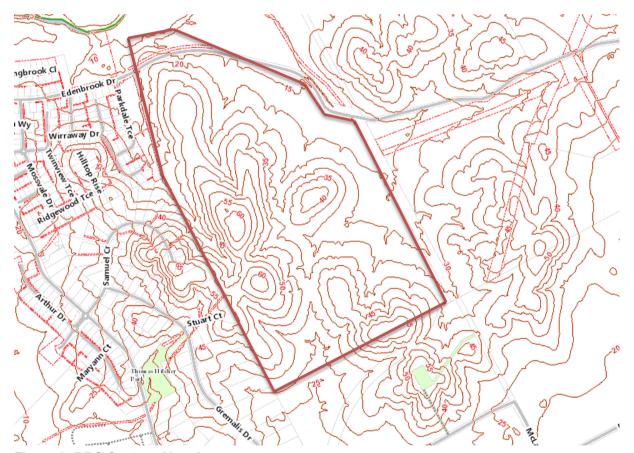
Figure 3: RRC Contour Mapping.

Reference to RCC's online contour mapping, the site is dominated by two prominent topographical features of high relief with a saddle connecting the two along the western part of the site. An elongated spur runs off to the north, with a number of smaller moderately sloping (between 10° and 15°) spurs running off to the north-east, to the east and to the south. A knoll is located atop of a spur towards the eastern part of the site. Steep (between 15° and 20°) re-entrants are located between the spurs. The site is also dominated by a second feature of high relief along the southern boundary of the site. As the site extends to the north-east, it generally flattens out.

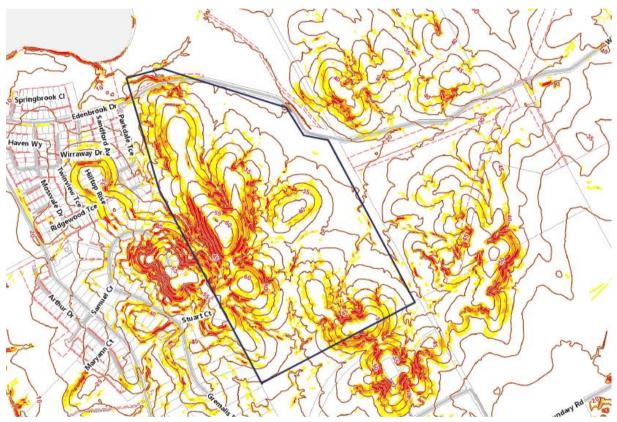
Figure 4: RRC Steep Land Overlay.

RCC's Steep Land Overlay identifies land with a slope of 15% or greater as being land potentially susceptible to landslide. Reference to the steep land overlay map (Figure 4), typically the moderately sloping side slopes of the spurs, and steeply sloping re-entrants are identified as steep land.

It should be noted that the steep land overlay map is a broad scale indication of the potential landslide susceptibility based on topography alone, and does not consider other factors such as regional geology or evidence of past instability.

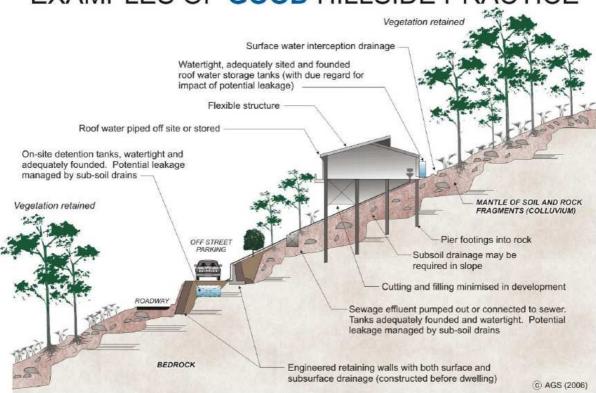
## **EXAMPLES OF GOOD HILLSIDE PRACTICE**

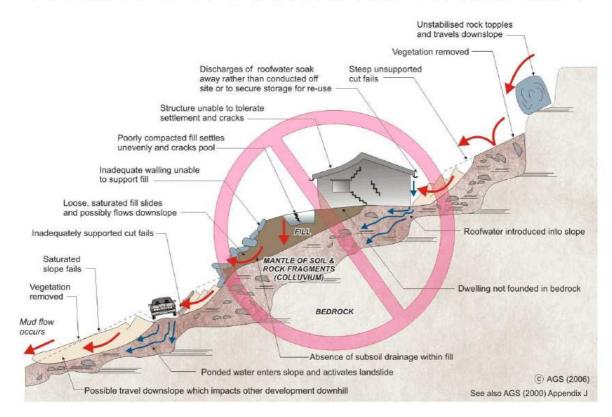
# **EXAMPLES OF POOR HILLSIDE PRACTICE**
