project
Edenbrook Estate
Edenbrook Drive, Parkhurst

plan of
Reconfiguration Plan
Stage 2
(36 Lots + Balance)

plan of
Concept Plan
1 Lot into 47 Lots (Stage 1) + 290 Lots + Bal)

Project 213255.00
May 2022

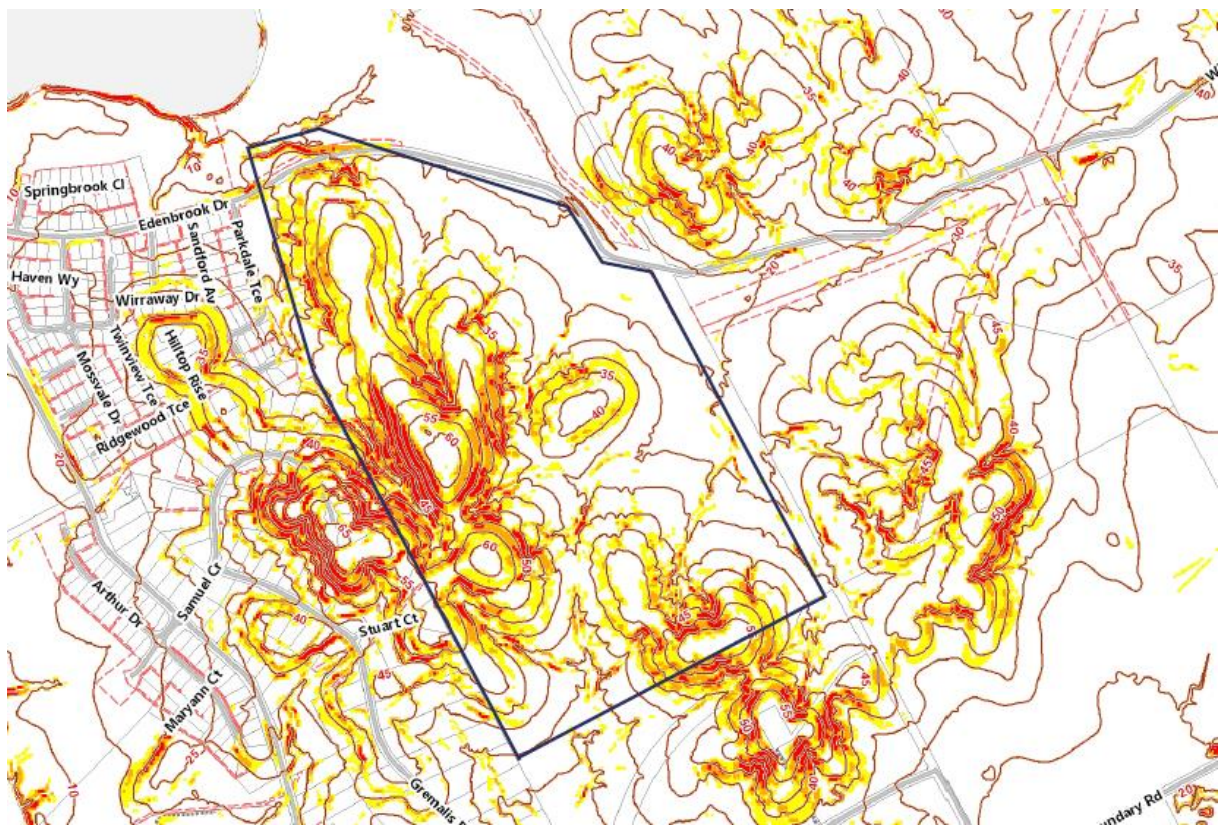
Figure 4: RCC Steep Land Overlay.

RCC's Steep Land Overlay identifies land with a slope of 15% or greater as being land potentially susceptible to landslide. Reference to the steep land overlay map (Figure 4), typically the moderately sloping side slopes of the spurs, and steeply sloping re-entrants are identified as steep land.

It should be noted that the steep land overlay map is a broad scale indication of the potential landslide susceptibility based on topography alone, and does not consider other factors such as regional geology or evidence of past instability.
