project
Edenbrook Estate
Edenbrook Drive, Parkhurst

plan of
Reconfiguration Plan
Stage 5
(42 Lots + Balance)

Project 213255.00
May 2022

Integrated Practical Solutions

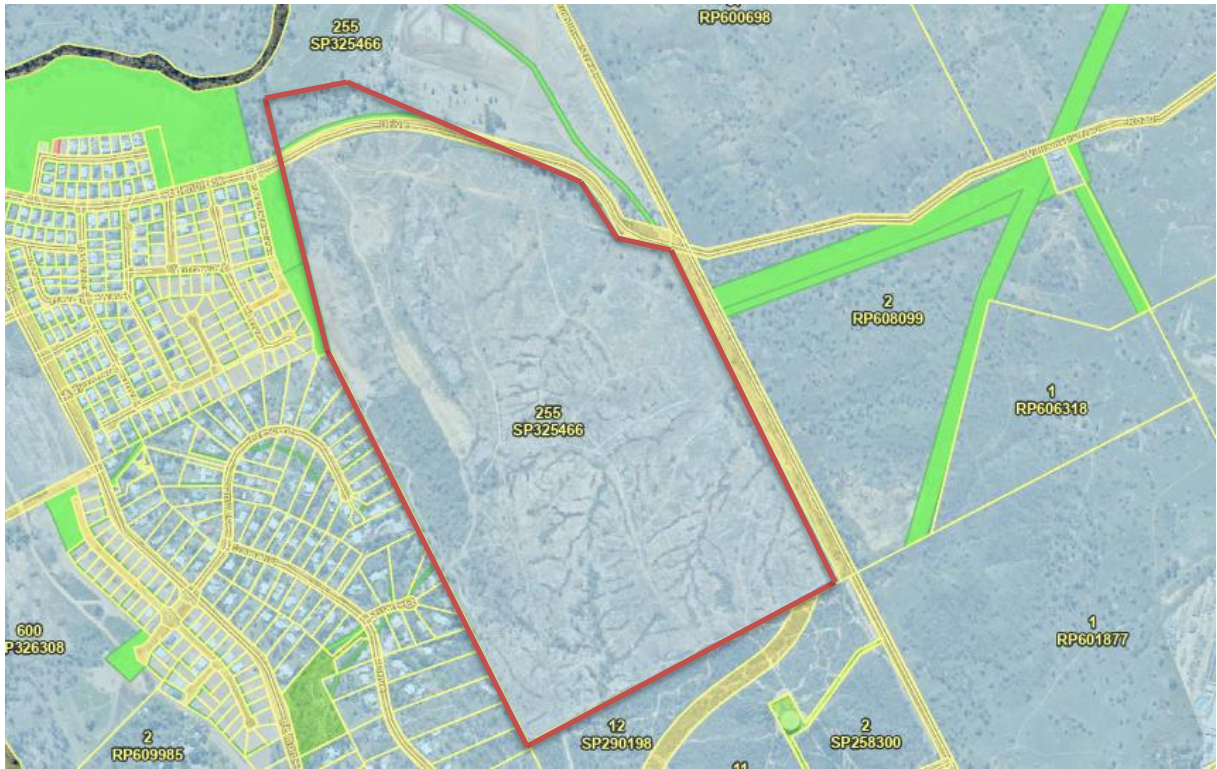
Figure 1: Site Location.

The development site is described as Lot 255 on SP325466, which encompasses both the northern and southern sides of Edenbrook Drive, Parkhurst (refer to Figure 1).

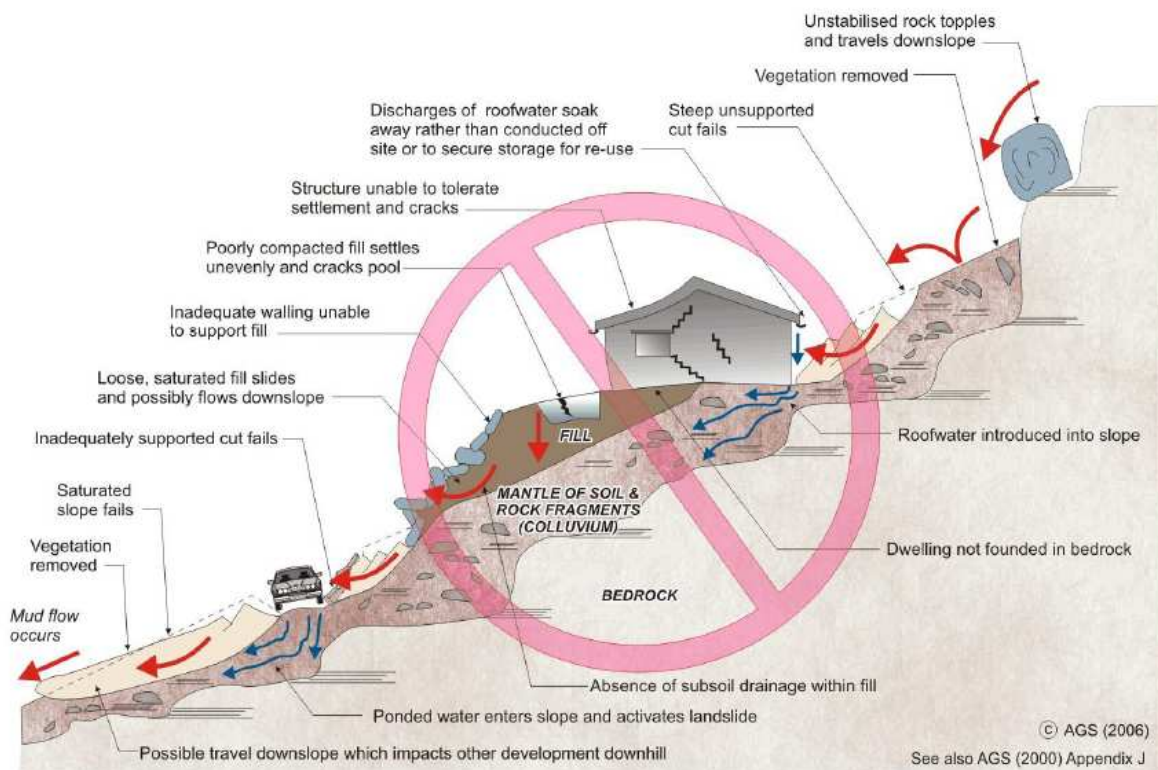
EXAMPLES OF **POOR** HILLSIDE PRACTICE
